Drivbiwire VNT15/17 repair procedure

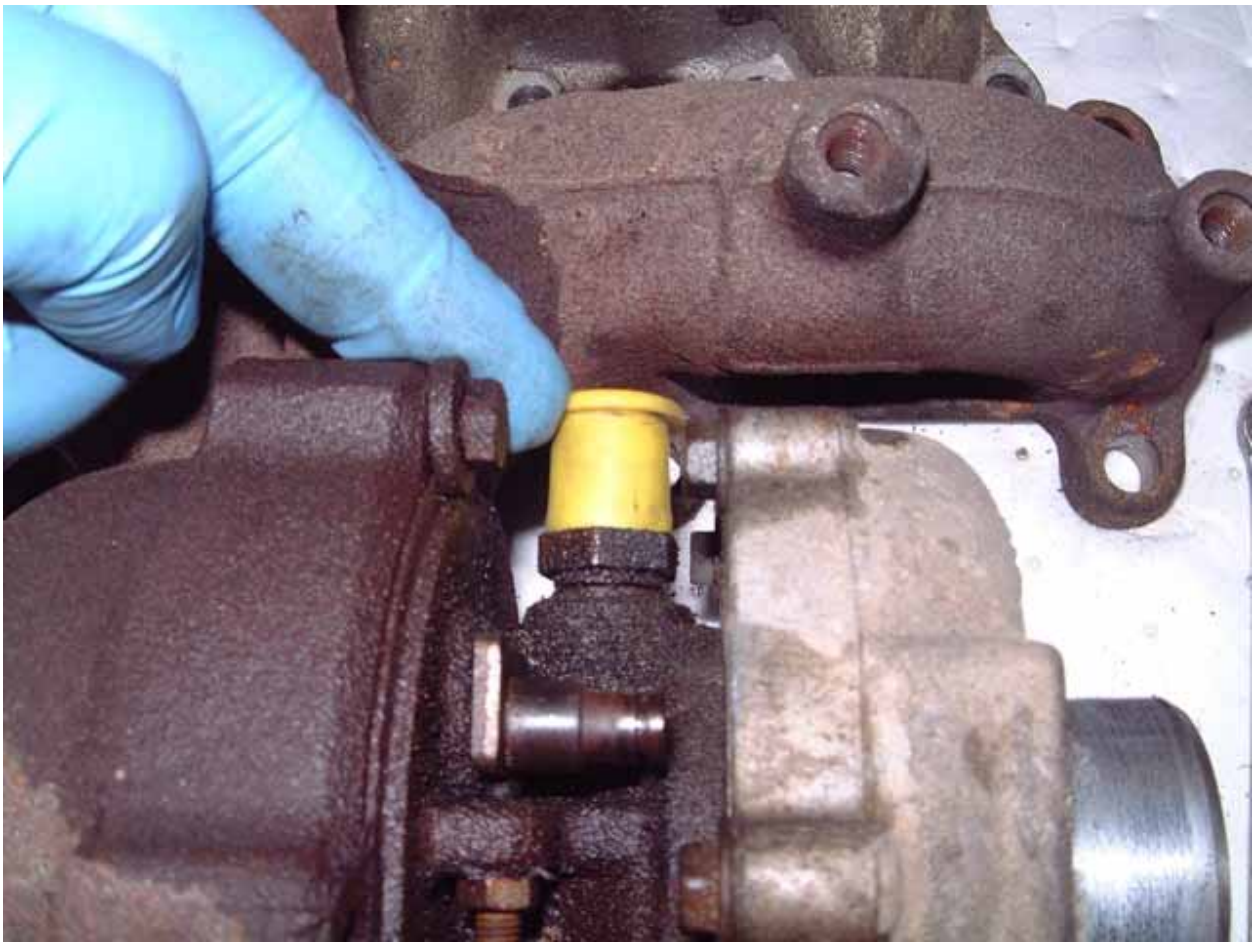
Always replace
oil line!

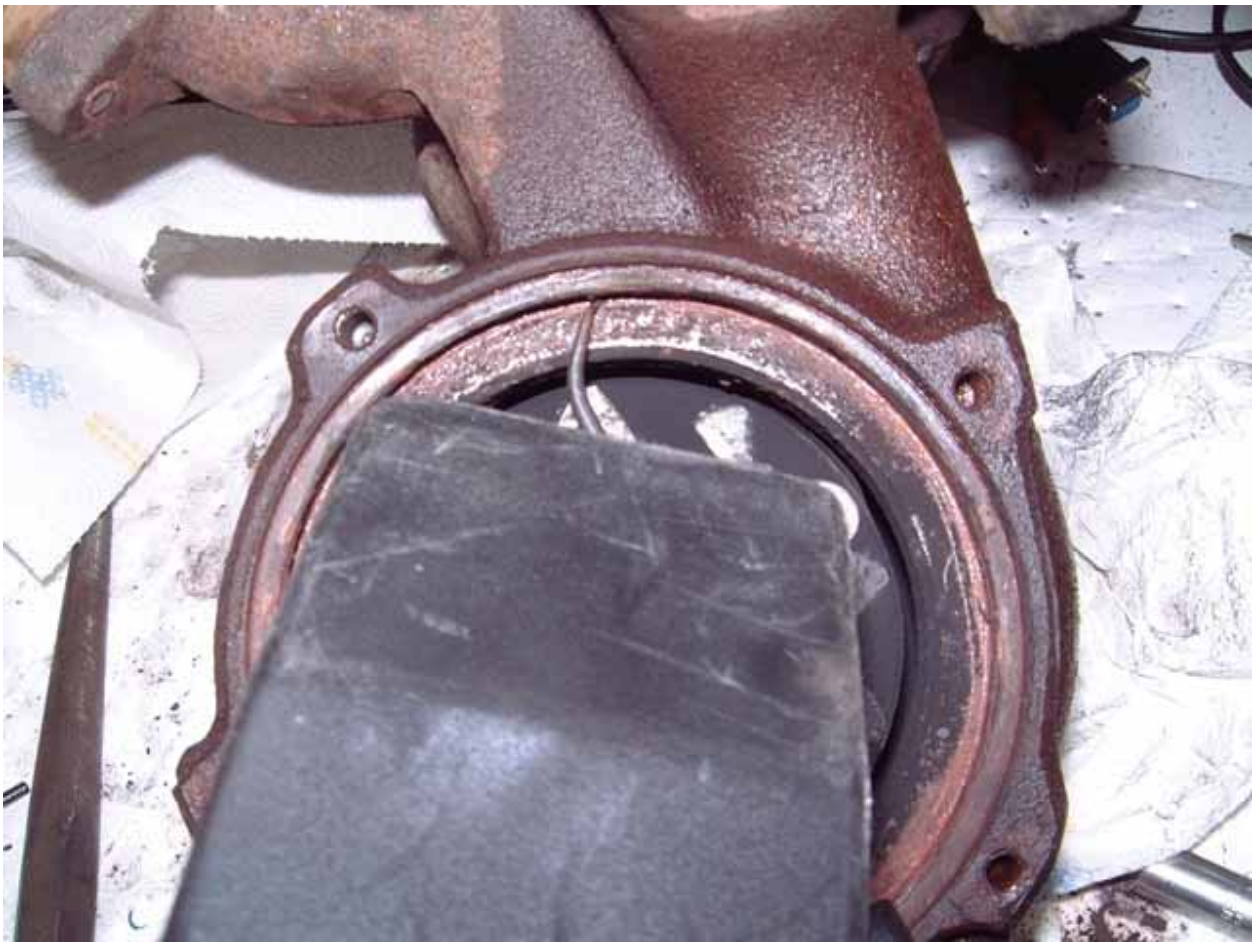
Raised spacer,
maintains clearance and
acts as a contact point
between VNT control
ring and Turbine housing

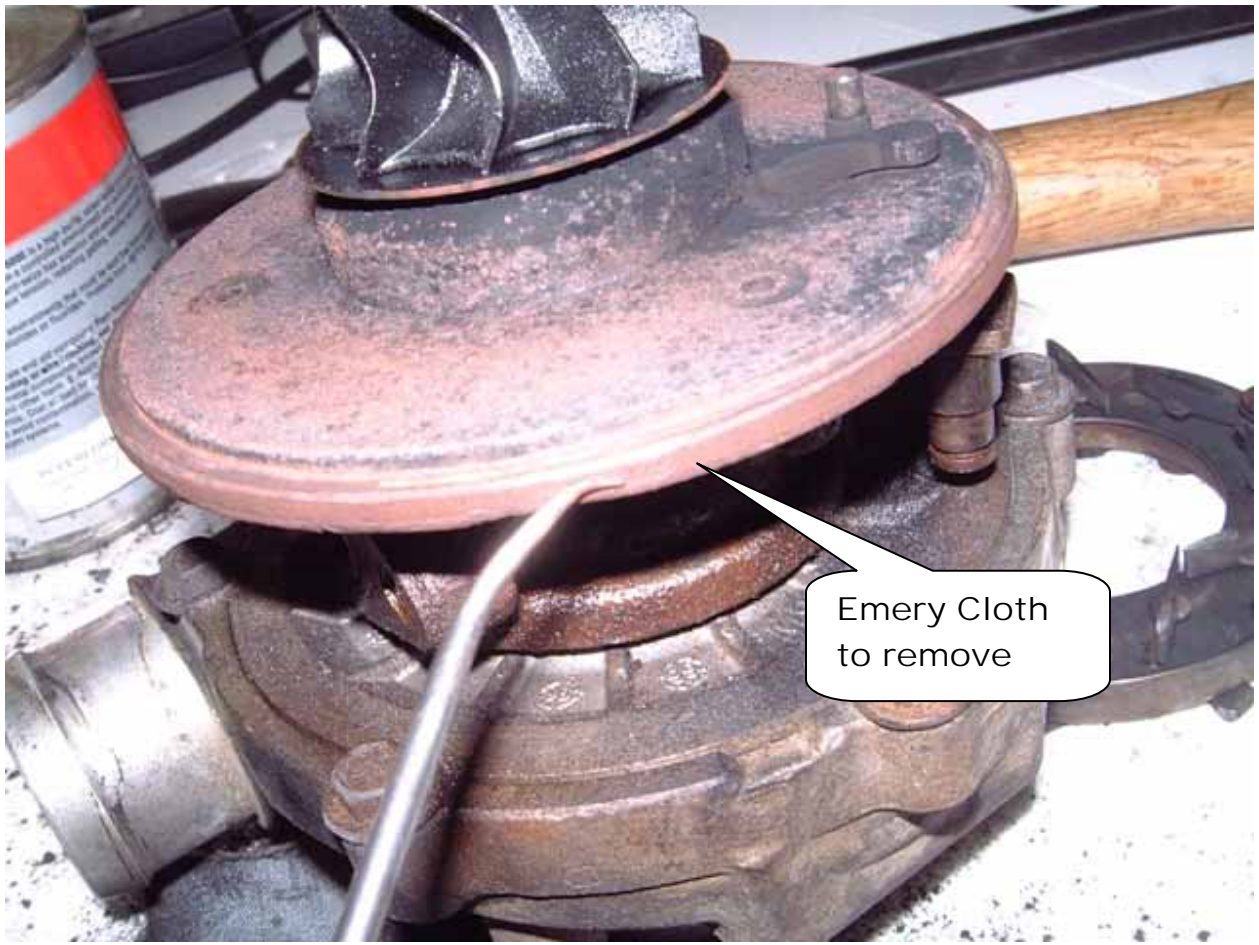
Alignment Pin

Internal VNT
ring actuator
Rod

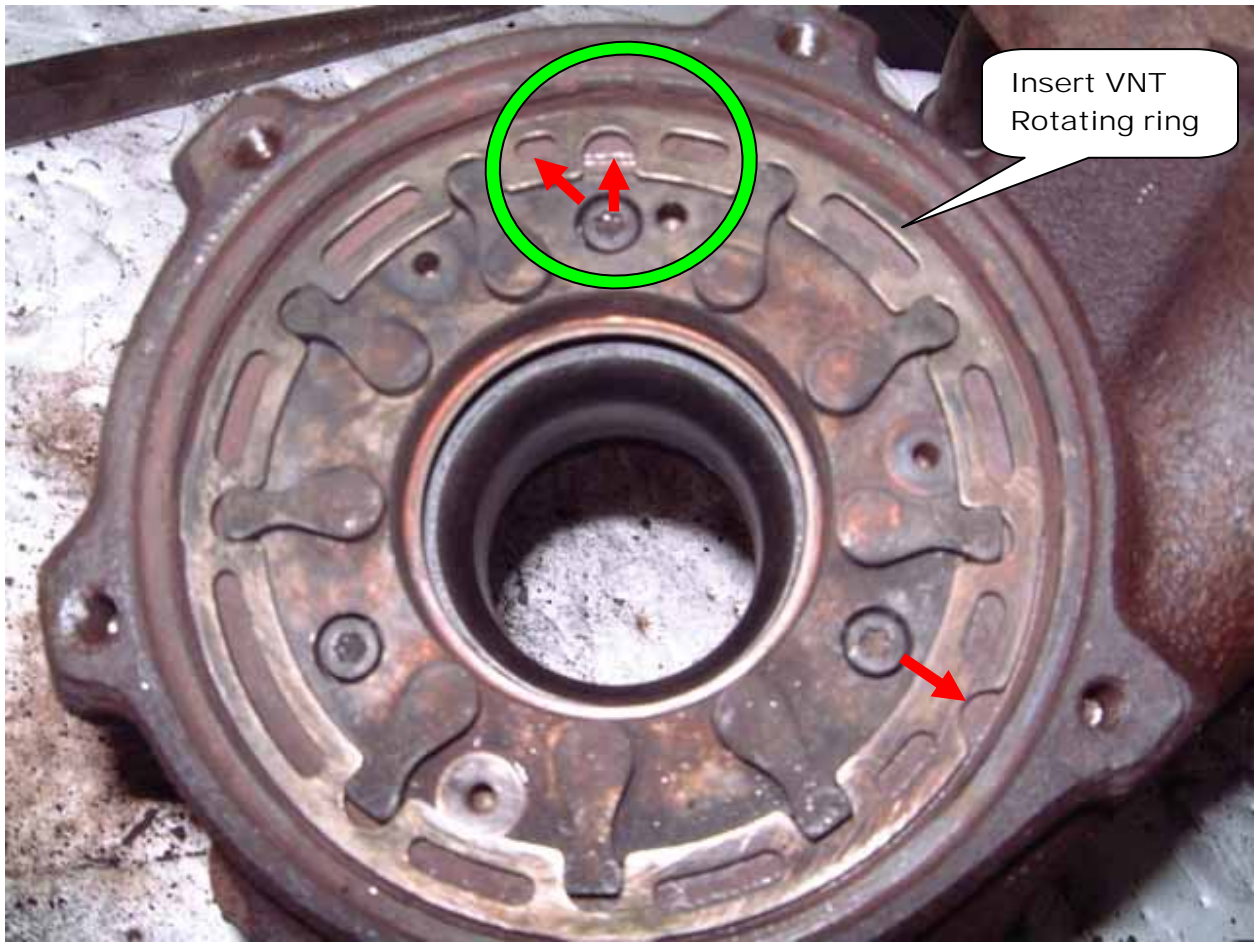
Note housing and Alignment pin position

Insert Guide vane plate then insert screws thru the plate and thru the spacer rings, make sure spacer rings did not fall out of position!!!
